Manhole Inspection Summary

Manhole # S37A__010MH

Inspection ☐ Is Incomplete Rating: **3) Fair**

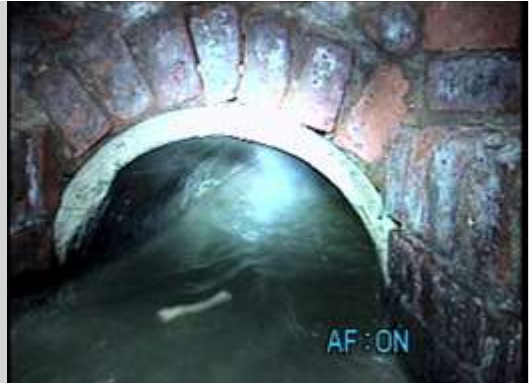
12 O'Clock Outflow

15 in. Circular Gravity Sewer
Pipe Out @ 12 O'Clock

Pipe Material: **Clay** ☐ Pipe Lined

Invert Depth: **10.20** (ft.) Flow Characteristics: **Fast**

Infiltration: **None** Pipe Seal Cond: **Unknown**

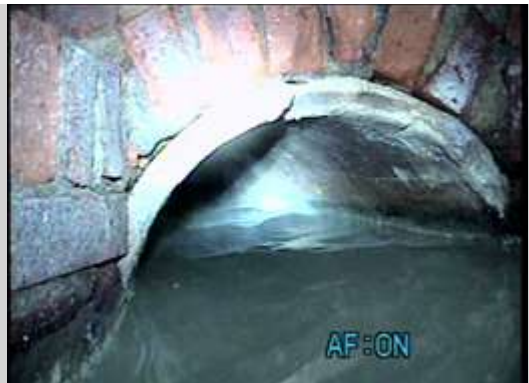
4 O'Clock Inflow

12 in. Circular Gravity Sewer
Pipe In @ 4 O'Clock

Pipe Material: **Clay** ☐ Pipe Lined

Infiltration: **None** Pipe Seal Cond: **Unknown**
